PROJECT 5077 71-73 WORTH ST, BRIDGEPORT, CT

COMMUNITY DEVELOPMENT BLOCK GRANT DISASTER RECOVERY PROGRAM owner occupied rehabilityation and rebuilding CONNECTICUT DEPARTMENT OF HOUSING HARTFORD, CONNECTICUT 06112

SCHEMATIC LAYOUT

EXTERIOR AND ROOF

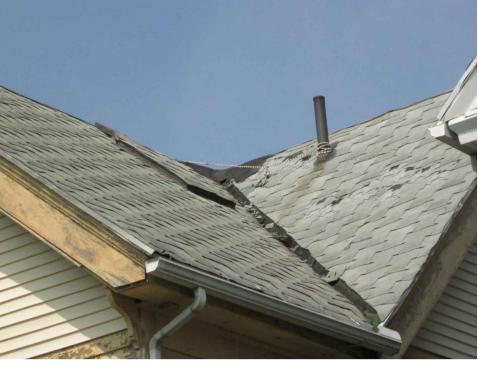
$\underbrace{PHOTO\ 2}_{\text{(EXISTING ROOF VALLEY REAR LEFT SIDE OF HOME)}}$

- 7 FURNISH AND INSTALL OPEN VALLEY METAL FLASHING ON MAIN ROOF VALLEY AS PER SPECIFICATIONS
- 8 REPLACE RAFTERS PER CONTRACT UNIT PRICING AND SISTER RAFTERS PER CONTACT UNIT PRICING AS NECESSARY. QUANTITIES TO BE FIELD VERIFIED BY CONTRACTOR AND MCA.

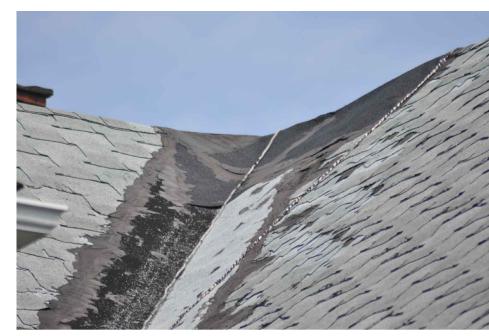
$\frac{PHOTO \ 3}{\text{(existing roof valley rear right side of home)}}$

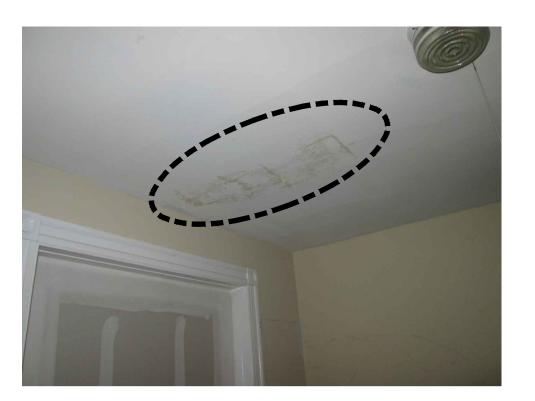
PHOTO 1

(WATER DAMAGED GYPSUM BOARD CEILING)

- DEMOLISH ALL CEILING GYPSUM BOARD AND WALL GYPSUM BOARD IN BATHROOM. APPLY ANTI-MICROBIAL TREATMENT. FURNISH AND INSTALL GYPSUM BOARD WHERE REMOVED. TAPE AND PAINT TO MATCH ADJACENT

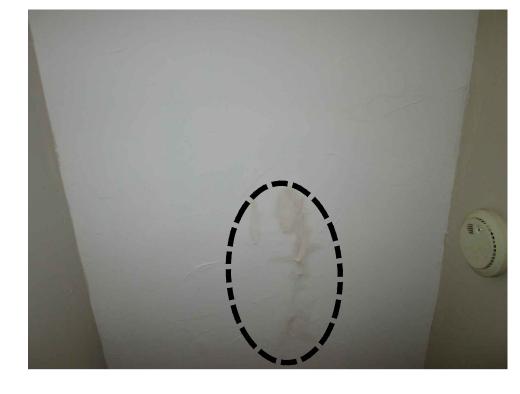
PHOTO 2
(HALL OUTSIDE BATHROOM)

- NON-INTACT LEADED SURFACE ON CEILING AND WALLS OF BATHROOM
 HALLWAY. DEMOLISH AND DISPOSE OF CEILING AND WALLS AND CEILING AS
 LEADED WASTE PER LEAD ABETMENT SPECIFICATION. FURNISH AND INSTALL
 NEW GYPSUM WALL BOARD. TAPE, PRIME, AND PAINT TO MATCH EXISTING

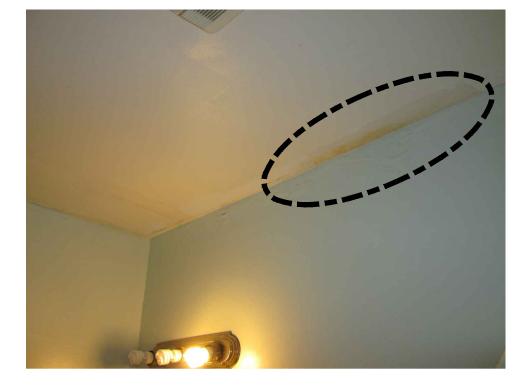
PHOTO 3

(WATER DAMAGED GYPSUM BOARD IN BATHROOM)

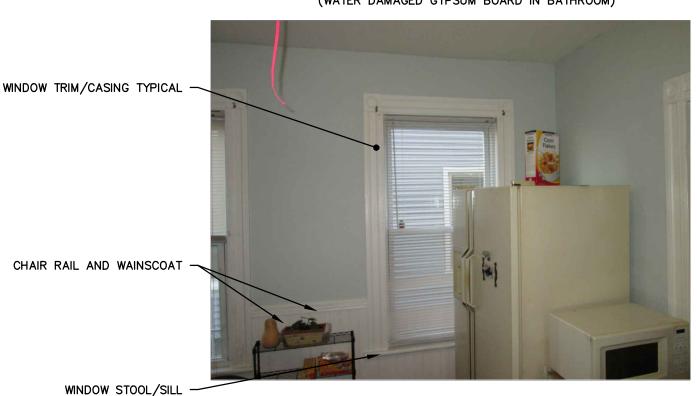
PHOTO 3

(KITCHEN WINDOW COMPONENTS TYPICAL)

- WOOD WINDOW TO BE REPLACED WITH ALL WOOD WINDOW REPLACEMENT FOR LEAD ABATEMENT. REMOVE AND REPLACE ALL STORM WINDOWS AND SCREENS AS REQUIRED TO COMPLETE WINDOW REPLACEMENT.

- 4 LIQUID ENCAPSULATE PANTRY DOOR CASING WITH CONNECTICUT DEPARTMENT OF PUBLIC HEALTH APPROVED ENCAPSULANT
- LIQUID ENCAPSULATE INTERIOR WINDOW TRIM AND STOOL WITH CONNECTICUT DEPARTMENT OF PUBLIC HEALTH APPROVED ENCAPSULANT

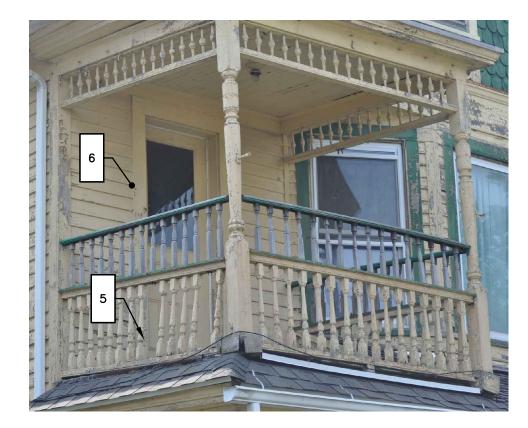
PHOTO 1 (2ND FLOOR PORCH EXISTING CONDITIONS)

- FURNISH AND INSTALL NEW SOLD WOOD DOOR FOR LEAD PAINT ABATEMENT. REPLACE ALL DOOR FRAMING COMPONENTS. INCLUDING CASING, DOOR SLAB
- REMOVE AND DISPOSE OF RAILINGS ON REAR SECOND FLOOR PORCH. FURNISH AND INSTALL NEW HAND RAILS AND BALLUSTERS ON REAR FIRST FLOOR PORCH TO MATCH PROFILE INSTALLED ON REAR FIRST FLOOR PORCH.

- STABILIZE AND LIQUID ENCAPSULATE ALL PORCH RAILINGS, COLUMNS, DECORATIVE TRIM AND WOOD MOLDING WITH CT DEPARTMENT OF PUBLIC HEALTH APPROVED LIQUID ENCAPSULANT

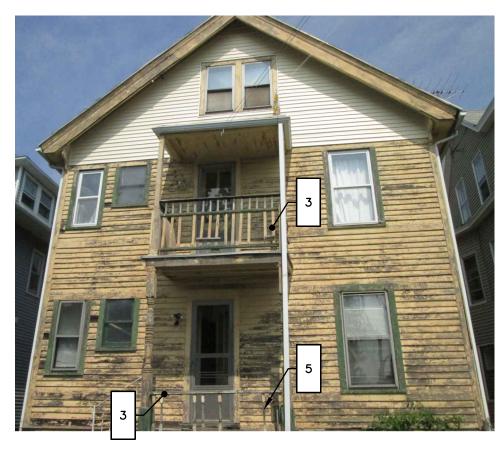
PHOTO 1 (REAR OF HOME)

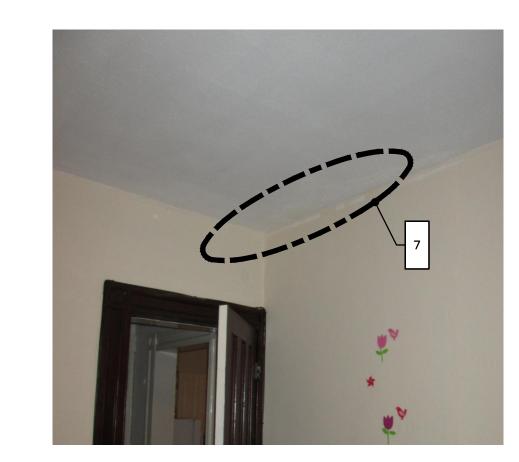
PHOTO 3 (WATER DAMAGED PLASTER CEILING FOR REPAIR)

- PATCH REPAIR WATER DAMAGE PLASTER CEILILNG IN FRONT LEFT BEDROOM. PRIME AND PAINT ENTIRE CEILING.

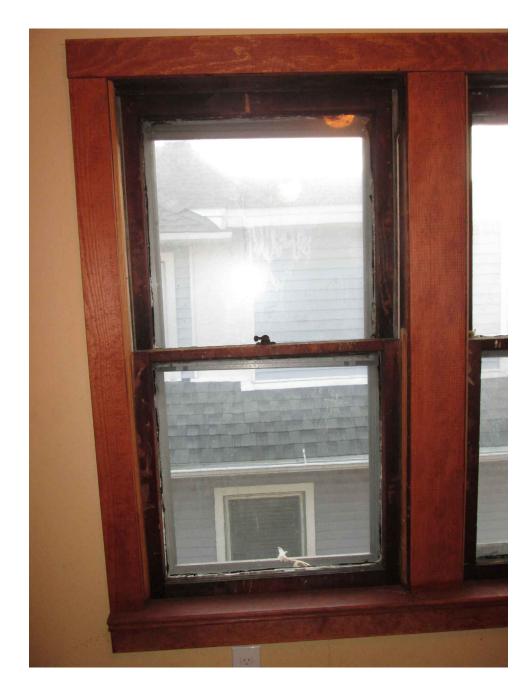
PHOTO 1 (WOOD WINDOW FOR REPLACEMENT AS PART OF LEAD PAINT ABATEMENT, TYPICAL)

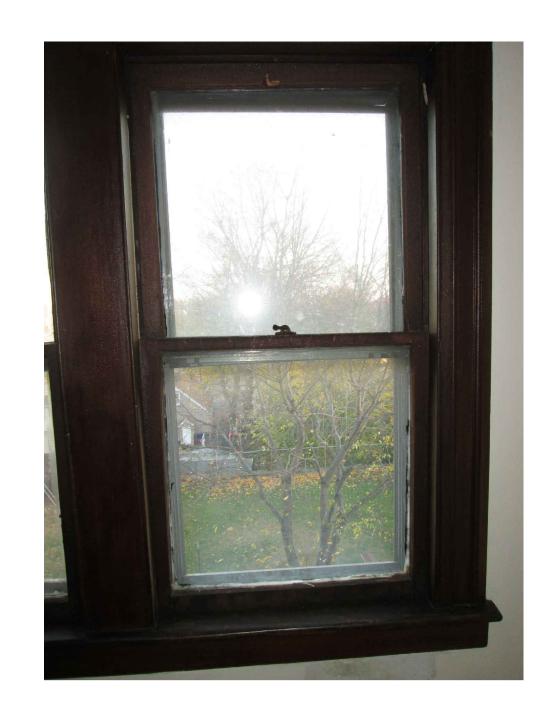
PHOTO 2 (WOOD WINDOW FOR REPLACEMENT AS PART OF LEAD PAINT ABATEMENT, TYPICAL)
